Improving the durability of stretch denim jeans

NEW
LOOK

Case study

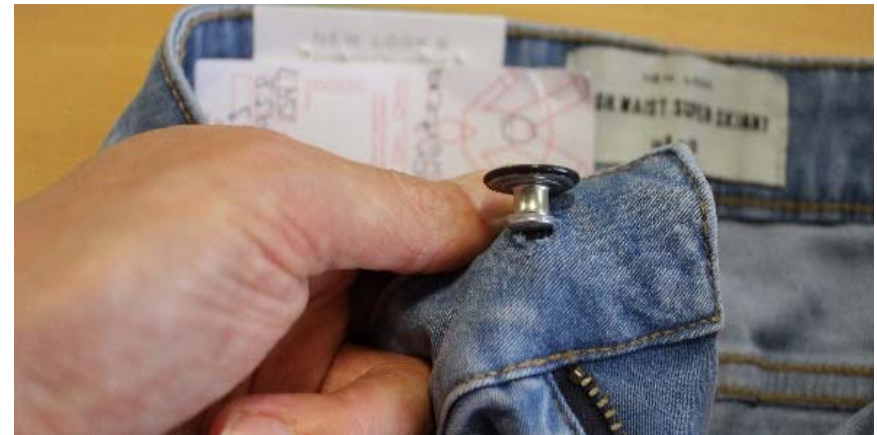
- A common failure was seen on the main waist button and fly area.
- Fabric was failing to support the button attachment under stress during wear.
- There was no evidence of the button itself failing.

Button failure example on stretch denim jeans

- Some of the faulty samples also featured a plastic washer attached to the underpart of the shank button. WRAP recommended New Look to test the use of the plastic washer and to compare it to the standard button attachment, in order to understand if this was bringing any performance improvements.

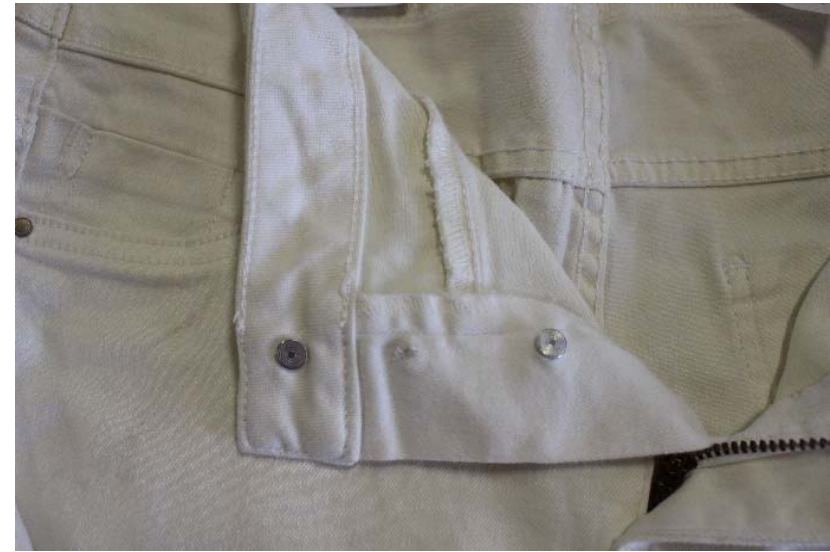
Failures were occurring across stretch fabric and style ranges
